**FOCUSED COMPLIANCE INSPECTION REPORT**

**INSPECTION DATE:** July 17, 2017

**SITE NAME:** Container Life Cycle Management, LLC  
d/b/a Mid-America Steel Drum, Inc.

**EPA ID NUMBER:** WIR 000 131 367

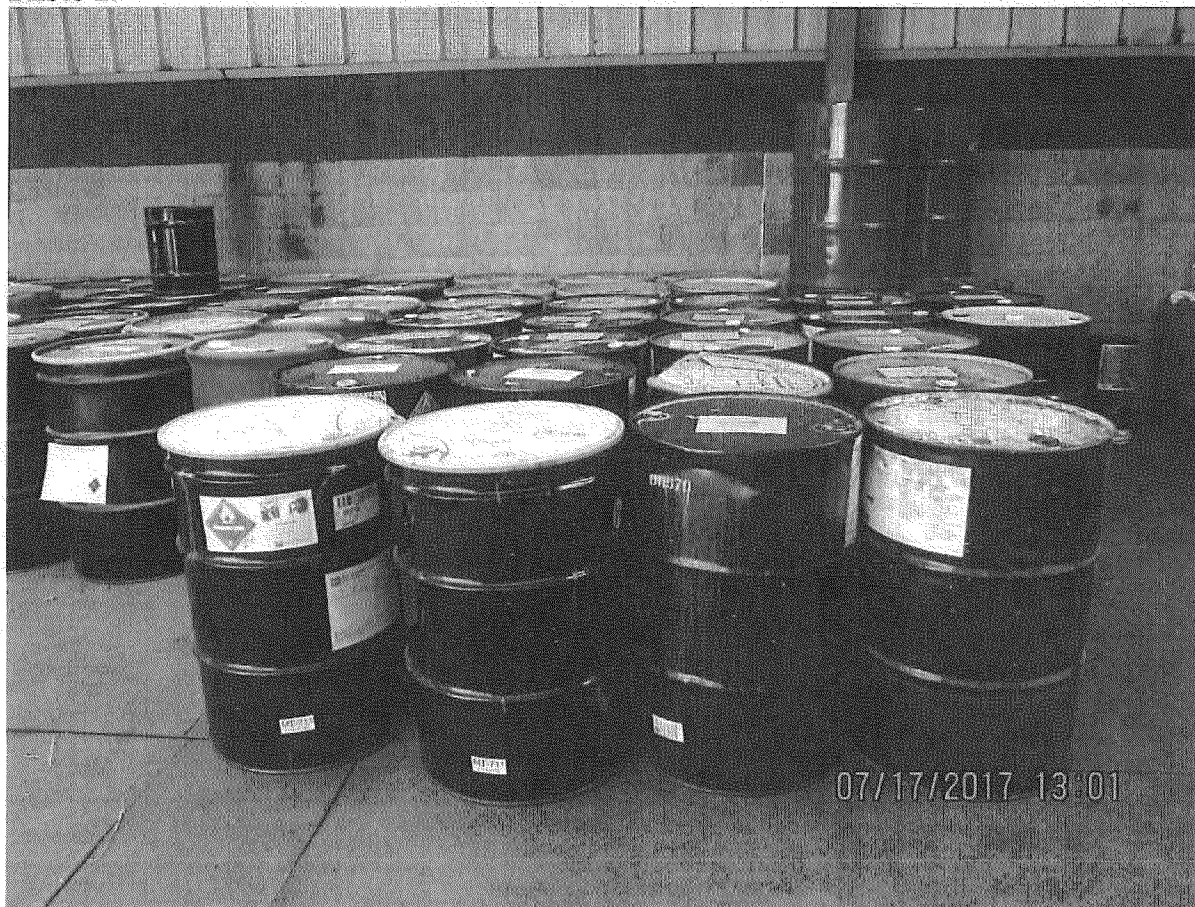
**Photo 1:**

Inspector Whitney and I proceeded to the "heavies" storage area where MASD segregates incoming drums that "feel" heavy because of liquid inside the drum. There were approximately 60 drums in the heavies area, each with a neon yellow reject label on the lid (See Photo 1 in the Inspection Photographs attachment). The labels stated "Rejected or Heavy Drum" and were marked with a tracking number and the customer that sent the drum. The vast majority of these labels had no date. For those labels with a date, the earliest observed was April 17, 2017 (Photo 2).

Photo	Image File Identifier	Description	Time (CST)	Image Modifications
1	IMG_0647	The "heavies" storage area with approximately 60 drums.	2:01 PM	None
2	IMG_0648	The oldest label observed on a drum in the heavies storage area, dated 4/17/17.	2:08 PM	None
3	FLIR0206	FLIR camera image of liquid line inside a steel drum in the heavies storage area.	Not Recorded	None
4	FLIR0207	FLIR camera image of poly drums inside a trailer that was being unloaded.	Not Recorded	None
5	IMG_0649	An open trailer of drums in the storage yard. It was unclear why this trailer was open.	2:19 PM	None
6	IMG_0650	An open trailer of drums and containers in the storage yard. Drums and containers were stacked and appeared toppled over. It was unclear why this trailer was open.	2:22 PM	None
7	IMG_0651	View of the bake oven with visible smoke near its exit. With camera flash on.	2:29 PM	None
8	IMG_0652	View of the bake oven with visible smoke near its exit. With camera flash off.	2:29 PM	None

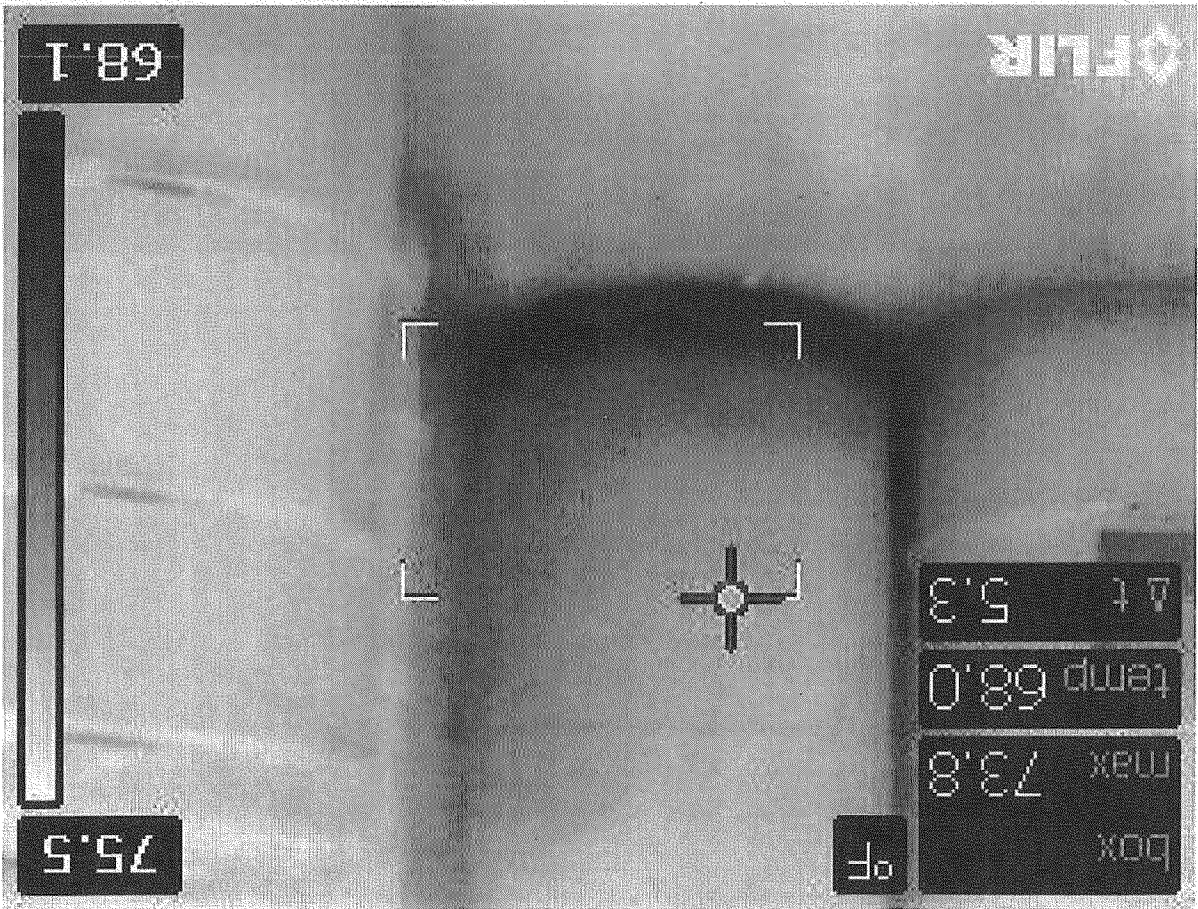
Photo 3:

Inspector Whitney attempted to use the FLIR camera to observe liquids inside the heavy drums. On a high contrast setting ("white hot"), the FLIR camera was able to image the liquid level inside at least one steel drum (Photo 3). It was confirmed that the FLIR camera was imaging the liquid inside the drum by tilting and holding the drum at an angle and observing the resultant contrast change along the lower drum wall. It appeared the FLIR camera was able to image the liquid level inside plastic "poly" drums, but the contrast was less clear (Photo 4). The highest mercury vapor reading in the heavies dock was 300 nanograms per cubic meter, or approximately 0.04 parts per billion.

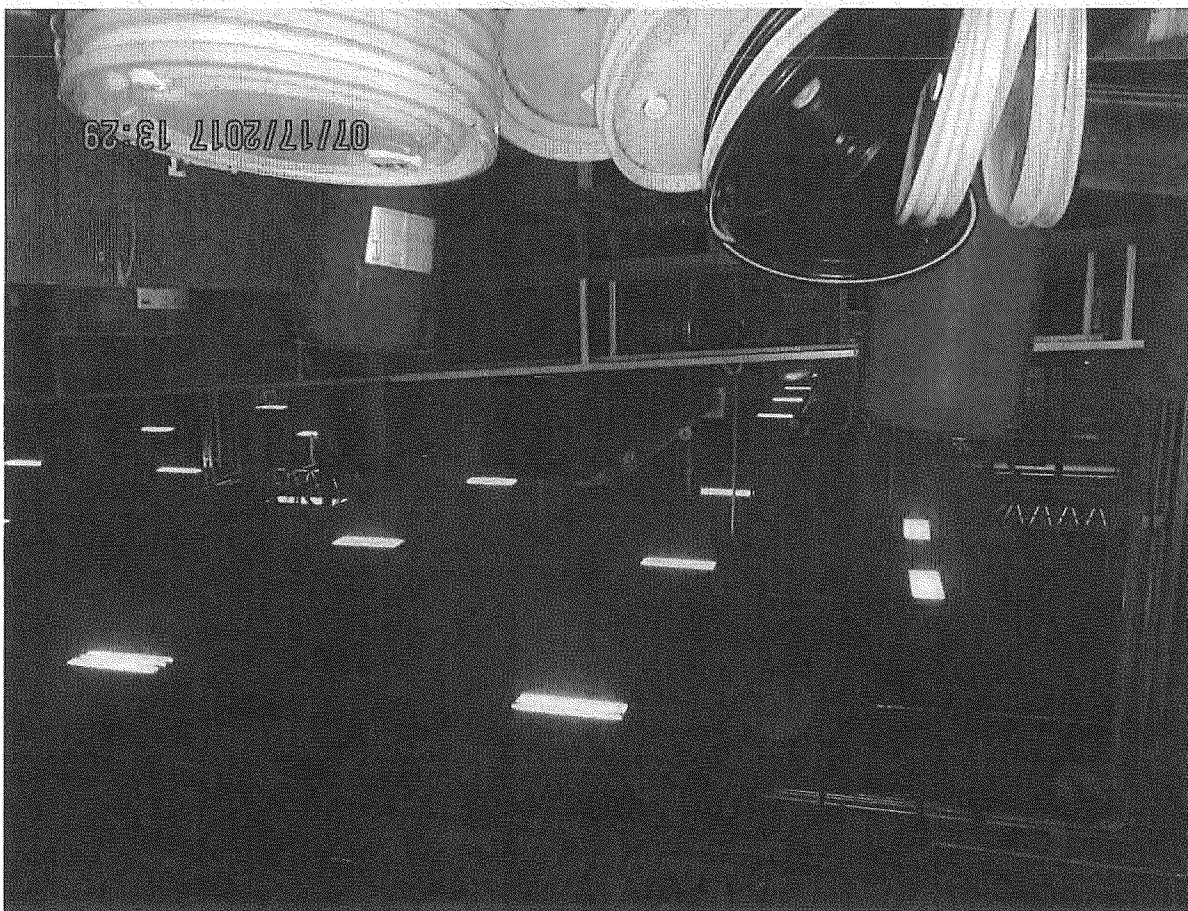
Photo 7:

facility and contributed to a standing haze (Photos 7 and 8). Mr. Laabs explained that the unit was the bake oven for newly-painted steel drums, which cures the coating MASD applies to drums after they pass inspection. Smoke was emanating from the exit of the bake oven where steel drums exit on a conveyor line. I asked Mr. Laabs what the smoke could be and he speculated that it was a combination of combustion byproducts and paint particles. The smoke was white in color and looked similar to the smoke seen outside the facility on South Pennsylvania Avenue. A video of the smoke was taken using the digital camera (See video file MVI\_0653.mov). Inspector Whitney imaged the smoke with the FLIR camera. It did not appear to have measurable volatiles content.

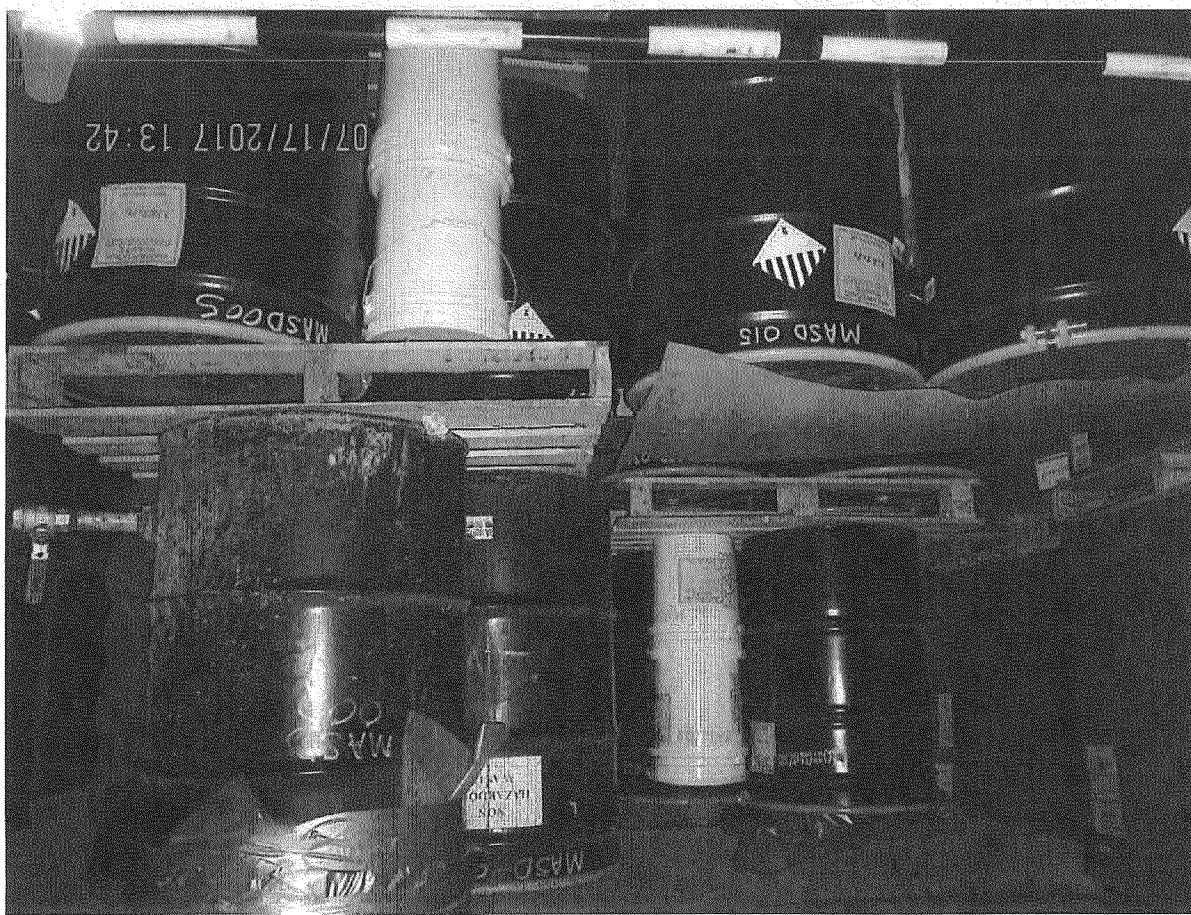
Photo 9:

Inspector Whitney and I continued to the southern side of the facility and observed a hazardous waste storage area. MASD had accumulated approximately two dozen containers of mercury-containing hazardous waste, including cardboard boxes, 5-gallon buckets and 55-gallon drums (Photo 9). The containers were marked as D009 hazardous waste. The earliest date on a 55-gallon drum in the area was April 24, 2017. The mercury vapor analyzer registered a maximum reading of 200 nanograms per cubic meter in this area, or approximately 0.02 parts per billion. It had been previously indicated by MASD representatives that the facility had received a "bad" drum that caused a mercury contamination event. This hazardous waste was generated as a result of a cleanup response.

9	IMG_0654	The mercury waste storage area.	2:42 PM	None
10	IMG_0656	Previously sampled drum (SFS08) now marked as "Save" near the wastewater treatment area.	2:45 PM	None
11	IMG_0655	Previously sampled drum (SFS09) now marked as "Save" near the wastewater treatment area.	2:25 PM	None
12	IMG_0657	A leaking drum marked as "Non Hazardous Waste" near the wastewater treatment area.	2:47 PM	None
13	IMG_0658	Inconclusive pH indicator paper result on the liquid in the leak seen in Photo 12.	2:47 PM	None

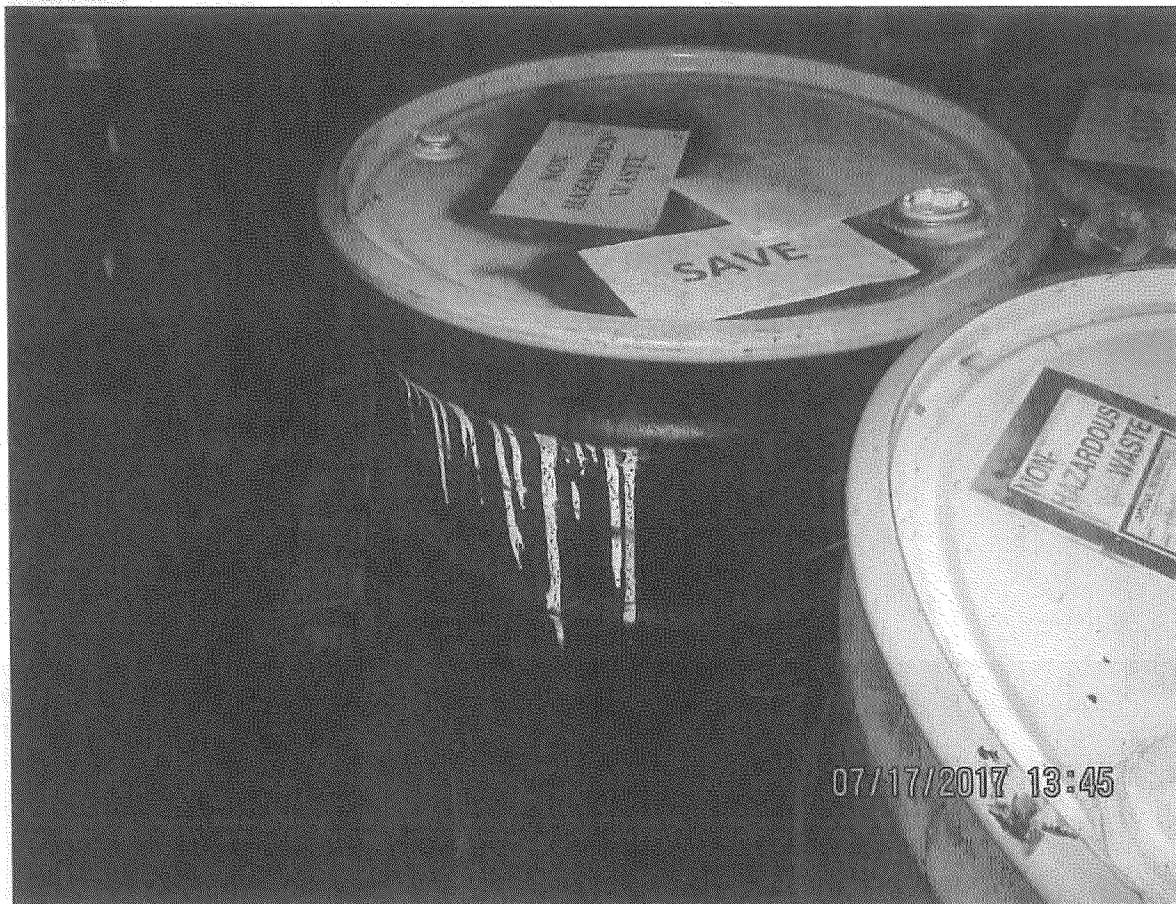
**Photo 10:**

Continuing west near the wastewater treatment area, I observed two 55-gallon drums that were previously sampled by EPA during a site visit on May 4, 2017. The drum samples were "SFS08" and "SFS09." Both drums were marked as "Non Hazardous Waste" and "SAVE" (Photos 10 and 11). Near these two drums was another 55-gallon steel drum marked as "Non Hazardous Waste" that appeared to be leaking onto the ground (Photo 12). I attempted to screen the leak with pH indicator paper but the result was inconclusive (Photo 13).
